STRUCTURE INSPECTION REPORT

East Broadway Street over Regional Enterprises Spur Track

Structure Number: 116-8001

April 16, 2014

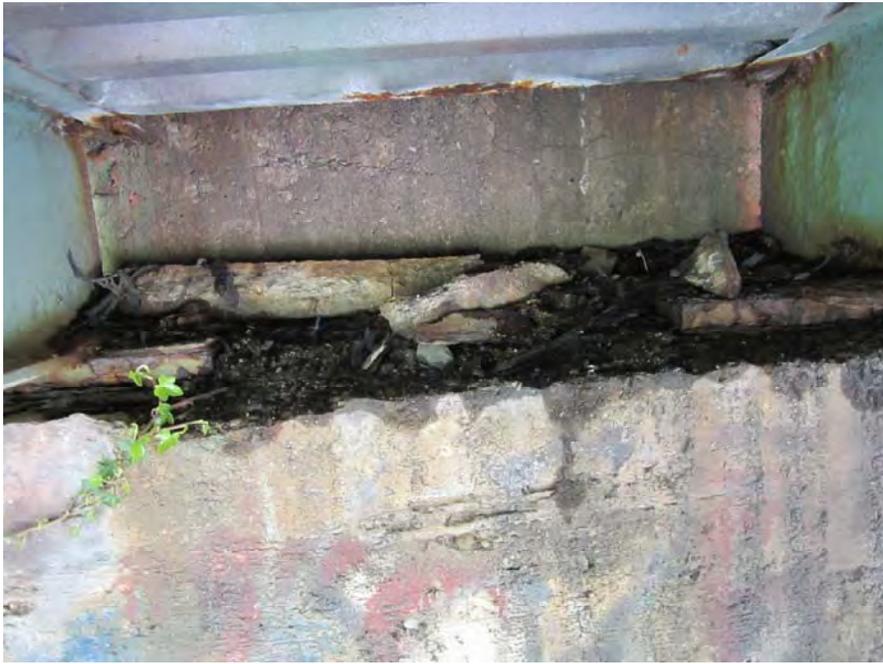
Photo # 1 - End of slab concrete spalled off due to water infiltration through deck joint at Abutment B.

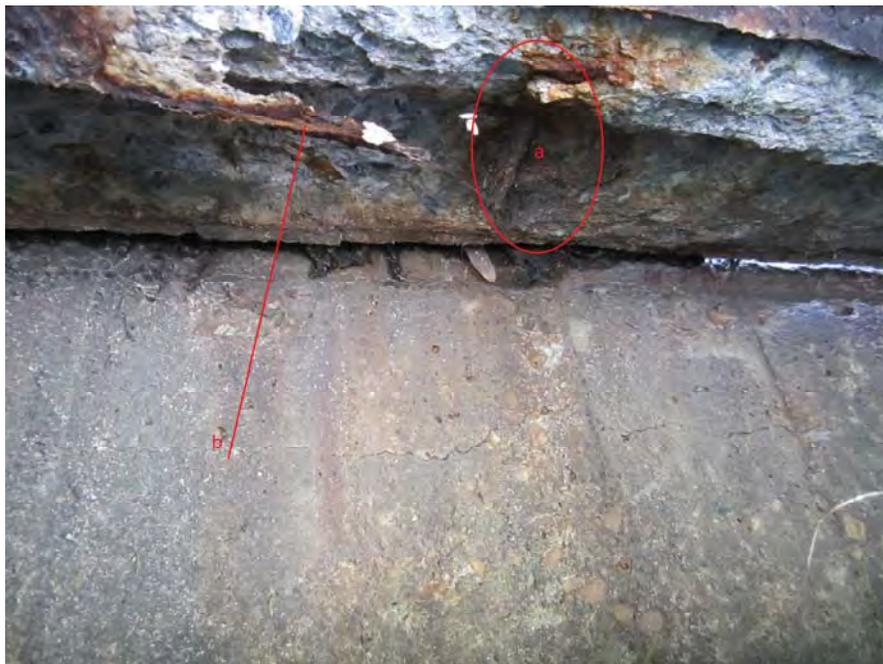
Photo # 2 - End of slab reinforcing exposed and severely corroded at Abutment B. (a. Longitudinal b. Transverse)

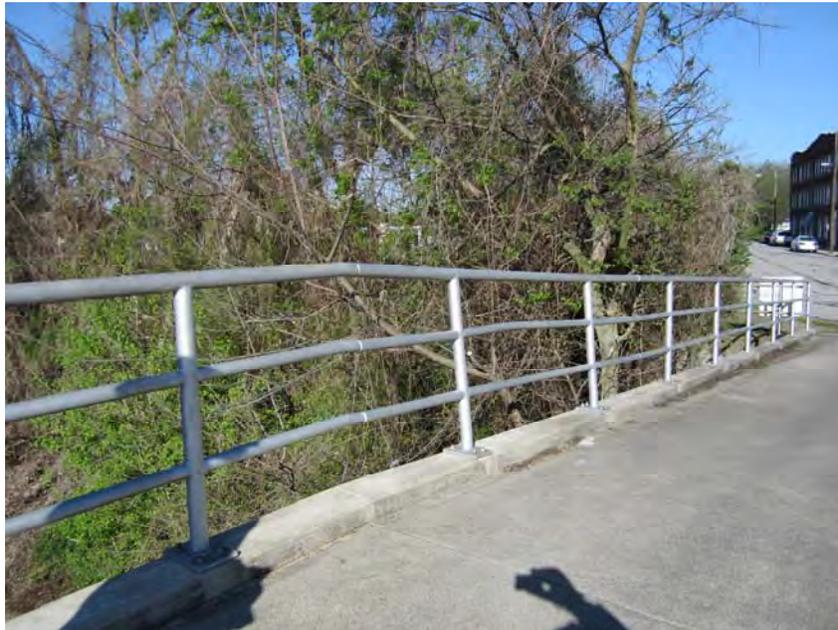
<u>Railing</u>	<p>Fair: The railing along the right side in Span 2 (adjacent to the sidewalk) is damaged with the three horizontal rails bent outboard 4" suggesting possible vehicular impact. See photo #3. Along the left side, the bottom rail is cracked in Span 3. See photo #4. The railing on the southwest wingwall is heavily corroded and has fallen away from the bridge.</p>
<u>Drains</u>	None
<u>Lighting</u>	No lights on the bridge. A street light is located on the approach roadway on the north side of Abutment A and on the approach roadway on the north side of Abutment B on utility poles.
<u>Utilities</u>	Good: Columbia gas line between Beams 8 and 9.
<u>Expansion Joints</u>	<p>Poor: Armor angles have light surface corrosion. Minor spalling between angles and the approach slabs. The compression seals have failed and are causing water to leak through the joints and onto the abutment seats and bearings. There is also debris buildup in the Abutment B joint. Abutment A seal is heavily deteriorated. See photo #5. Seal is cracked and deteriorated significantly. The Abutment A armor angle anchor bolt has a missing nut at Beam 9. Portions (6 LF) of the Abutment B seal are lying on top of the abutment seat, note daylight through joint. See photo #6&7.</p>

Photo # 3 - Damage to the three horizontal rails on the railing along the right side of the bridge in Span 2.

1. Repair bent railing and weld repair cracked bridge rail or alternately, upgrade railing on bridge.
2. Replace compression seals in the expansion joints at both ends of bridge.
3. Paint angles at ends of bridge that are part of the expansion joints.
4. Repair abutment seats at each abutment.
5. Repair/replace bearing assemblies for all beams at each abutment.
6. Replace bolt that has a sheared off head located at beam to bent cap connection.
7. Clean and paint structure steel.

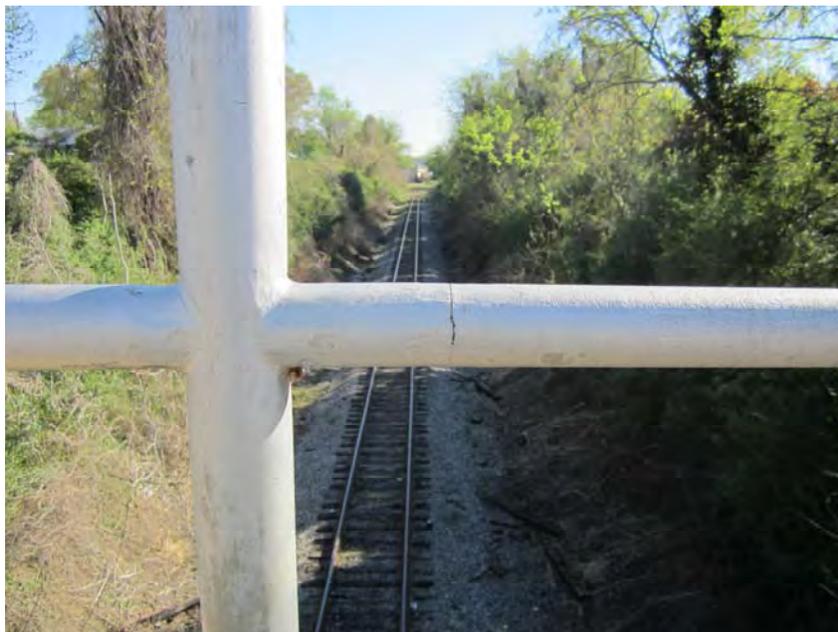
Photo # 4 - View of the cracked railing member on the left side of the bridge in Span 3.

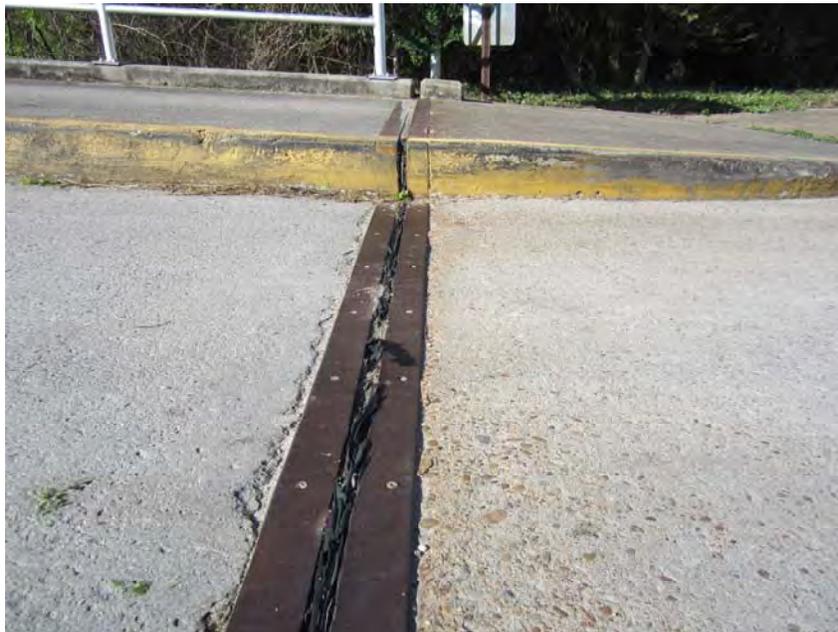
Photo #5 - View of the deteriorated seal at Abutment A.

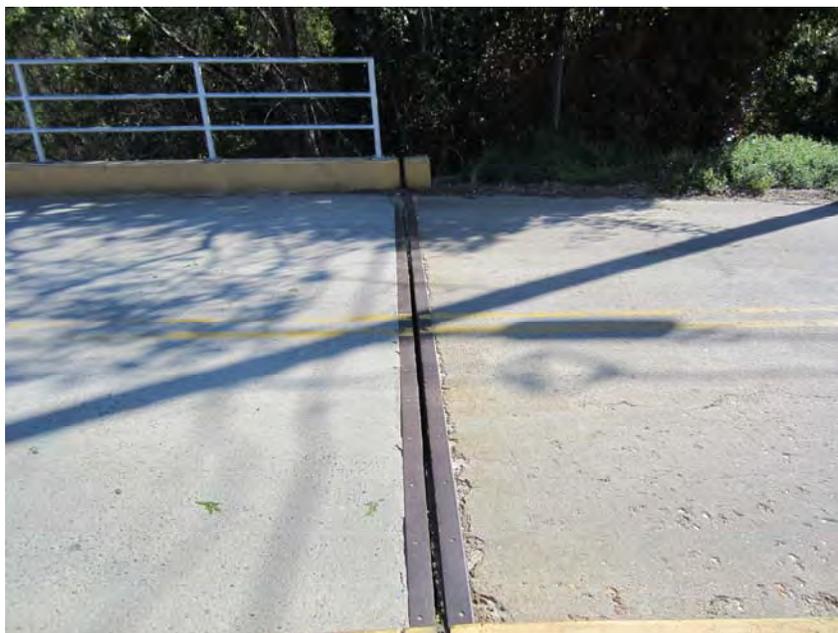
Photo #6 - View of depressed seal at Abutment B.

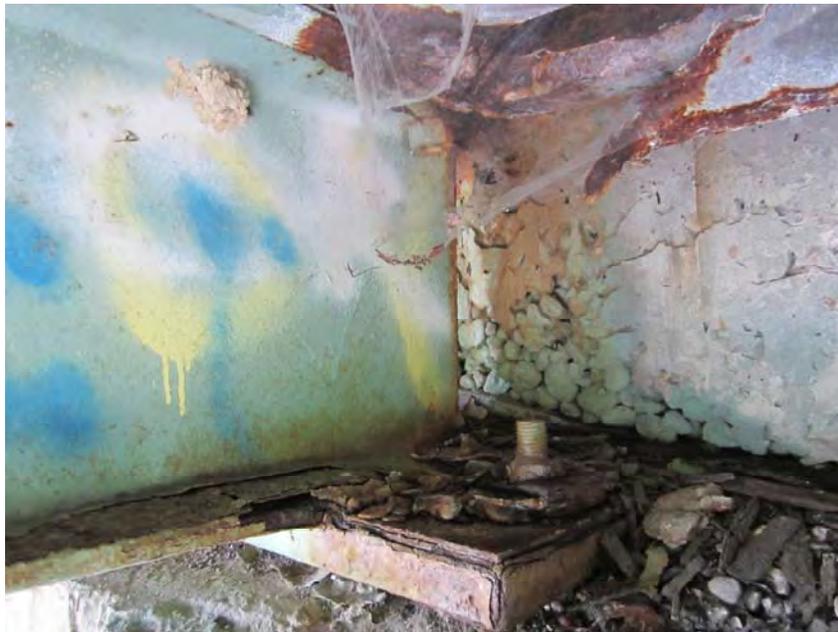
SUPERSTRUCTURE	GENERAL CONDITION RATING 5
<u>Bearings Devices</u>	Fair: All bearings of both abutments have lost bearing under the masonry plate due to deterioration of the abutment seat concrete. See photo #8. The bearing assemblies at Abutment A have minor surface corrosion with heavy amounts of corrosion on the bearing assembly of Beam 7. The bearing assemblies at Abutment B have a heavy corrosion with loss of section to the anchor bolts and beveled masonry plates.
<u>Stringers</u>	None
GIRDERS, BEAMS OR SLABS	
<u>Beams</u>	Fair: All beams have light surface corrosion. Minor graffiti present on beams. All beams are pitted on the webs and flanges with minor residual loss of section to the bottom flanges of the beams at the bearings.
	The beams in Span 3 have 5% section loss typical with light to moderate corrosion on top of bottom flange. The beam-to-cap connection at the west end of Beam 5 in Span 3 has pack rust.

Photo #8 - Typical loss of bearing under bearings at abutments.

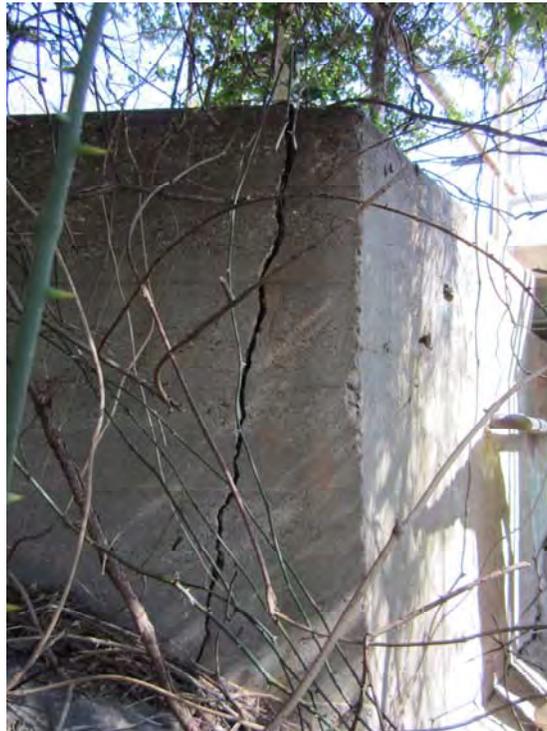
SUBSTRUCTURE	GENERAL CONDITION RATING 1
ABUTMENTS	
<u>Wingwalls</u>	The southwest wingwall has a 1¼" top to ½" bottom open vertical crack and had rotated forward 3/8" at the top. See photos #9&10.
<u>Backwalls</u>	Fair: Abutment A has moderate honeycombing throughout.
<u>Bearing Seats</u>	Poor: The entire seat area of both abutments has disintegrated concrete with loss of bearing under the masonry plate of all bearings. See photo #8. Debris (dirt, vegetation, spalled concrete) is also present on the bearing seats in Abutment B only.
<u>Breastwall</u>	Fair: Abutment A has 4 vertical hairline cracks, 7 LF total. Abutment B has one vertical hairline crack, 4 LF total and an area of concrete disintegration on south end 18" wide x 4 LF high with no reinforcing steel exposed. Both breastwalls have minor honeycombing.
<u>Weep Holes</u>	None
<u>Footings</u>	Not visible.
<u>Piles</u>	Not visible.
<u>Undermining</u>	No undermining observed.

Photo # 9 - Side view of Southwest wingwall showing 1¼" top to ½" bottom open vertical crack.

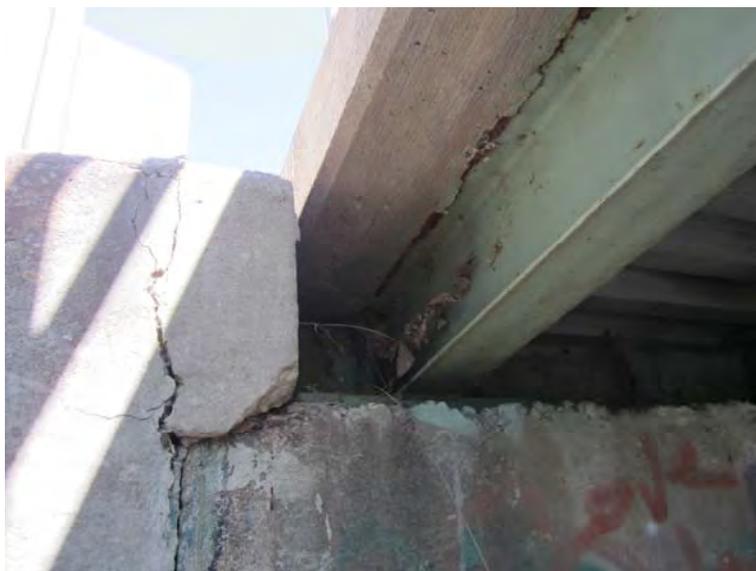
Photo # 10 - View of southwest wingwall showing 3/8" forward rotation at top.

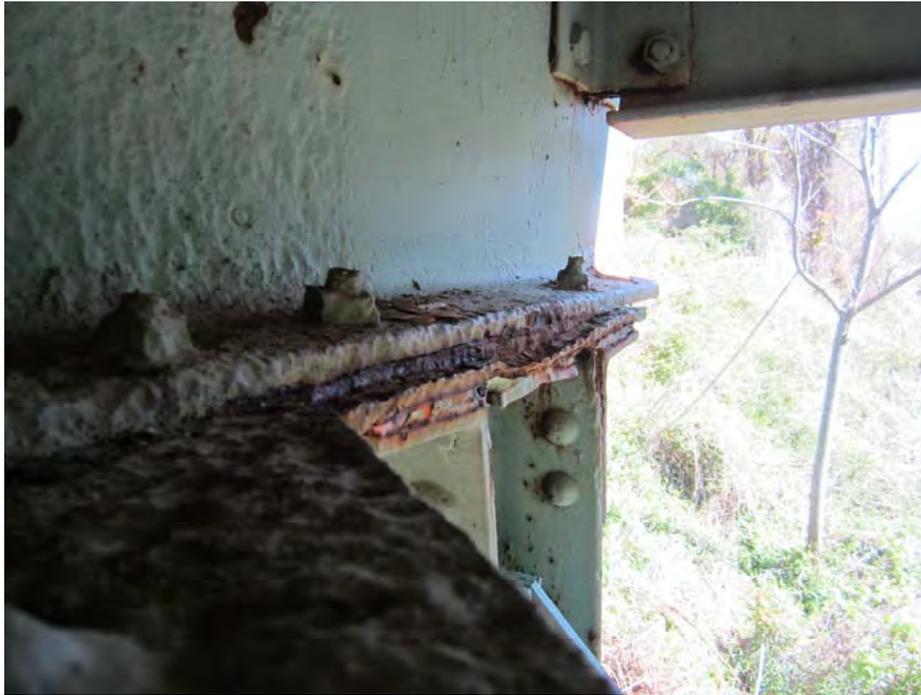
Photo # 11 - View of typical pack rust between column and bent cap.

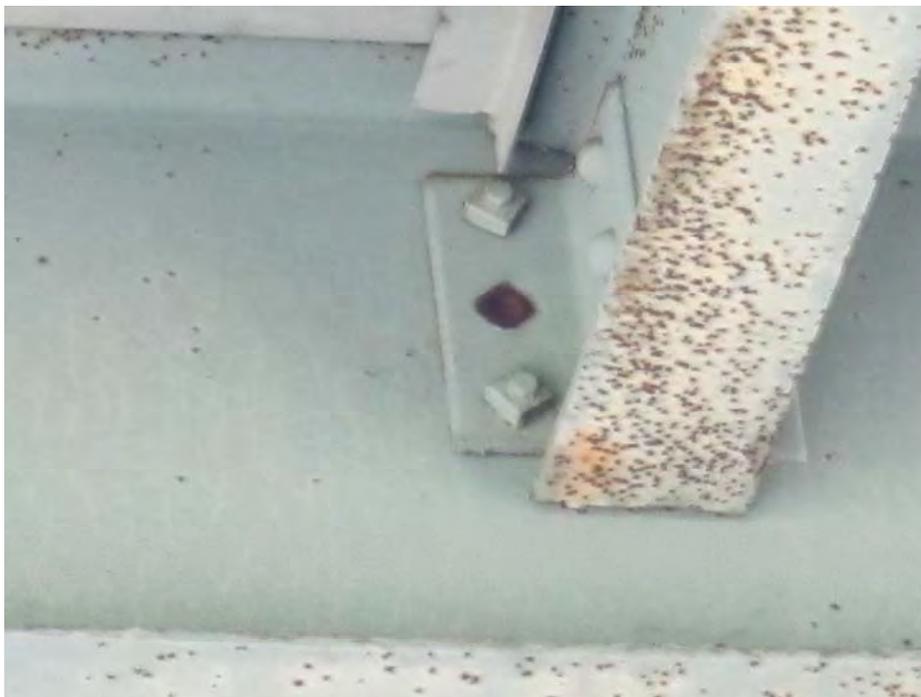
The exterior beams have heavier amounts of corrosion with significant amounts of pack rust existing around the bottom of the beam's double angle to bent cap connections.
	Numerous beams have had the original rivets and/or bolts replaced with new bolts. At Bent 3, Beam 4 of Span 3, the center connection bolt head has sheared off from the beam's angle to bent cap connection. See photo #12. Bolt head is missing on the left side angle connection as facing Abutment B. Hold-down bolt for Beam 9 at Bent 4 is deformed due to pack rust.
	Beam 2 in Span 4 has two perforations 1/2" high x 2" wide average at the top of the web near Bent 4.
<u>Diaphragms</u>	None
<u>Cross Frames</u>	None
<u>Bracing</u>	None
FLOORBEAMS	None
TRUSSES	
<u>Portals</u>	None
<u>Bracing</u>	None
PAINT	Fair: Areas of light surface corrosion throughout superstructure and substructure. Several areas of exfoliations have been painted over indicating insufficient cleaning before painting. See photo #22. Pack rust exists at most connections. No active corrosion stains are present. Minor graffiti.

Photo # 12 – Center connection bolt head sheared off from 4th beam's angle at Bent 3 (span 3).

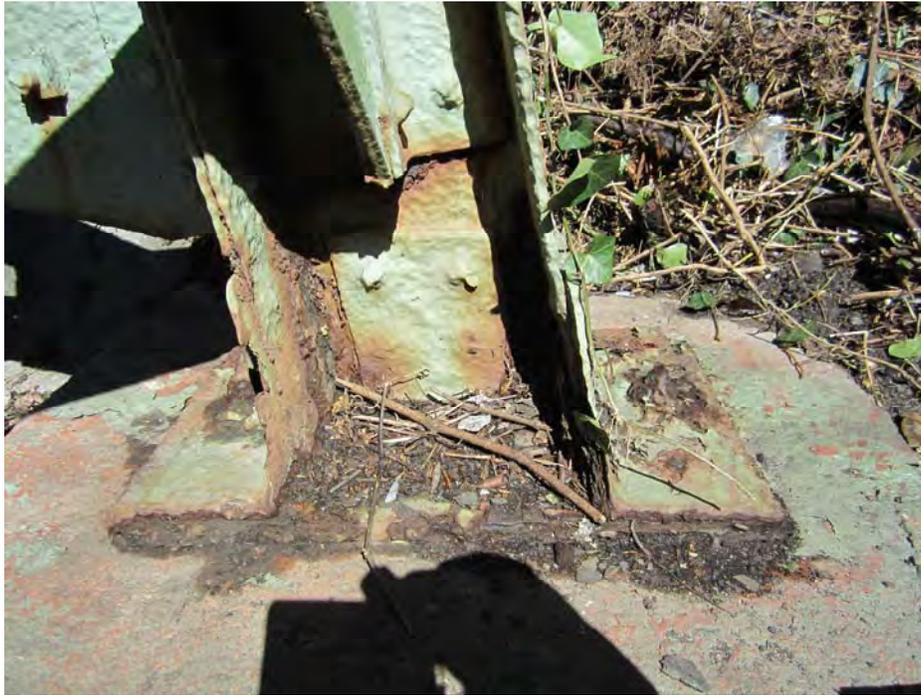
In general, the bottom six inches of the column flanges along the north side of the structure have up to 50% loss of section. Angles connecting the column web and flanges to the base plates at the column bases, two have up to 100% loss of section. [See photo #13](#). Nine anchor bolts have up to 50% loss of section. [See photo #21](#). The inside anchor bolt at the north column at Bent 2 is missing with 100% loss of section. Also, substantial deterioration of the horizontal bracing element is observed at this location. [See photo #14](#).

Photo # 13 - Typical condition of the bases of the north columns of Bents 1-4 (Bent 1 shown)

1. Repair lower ends of steel columns, replace connection angles and column support base plates.
2. Replace Bent Cap #4 which has significant section loss.
3. Replace anchor bolts at all bent columns.
4. Replace diagonal bracing between bent columns at each bent.
5. Replace horizontal cross bracing between Bent 1 and 2 and between Bent 3 and 4.
6. Stiffen vertical cross bracing between Bents 1 and 2 and between Bents 3 and 4 which are bowed.
7. Repair concrete pedestals at base of bent columns.

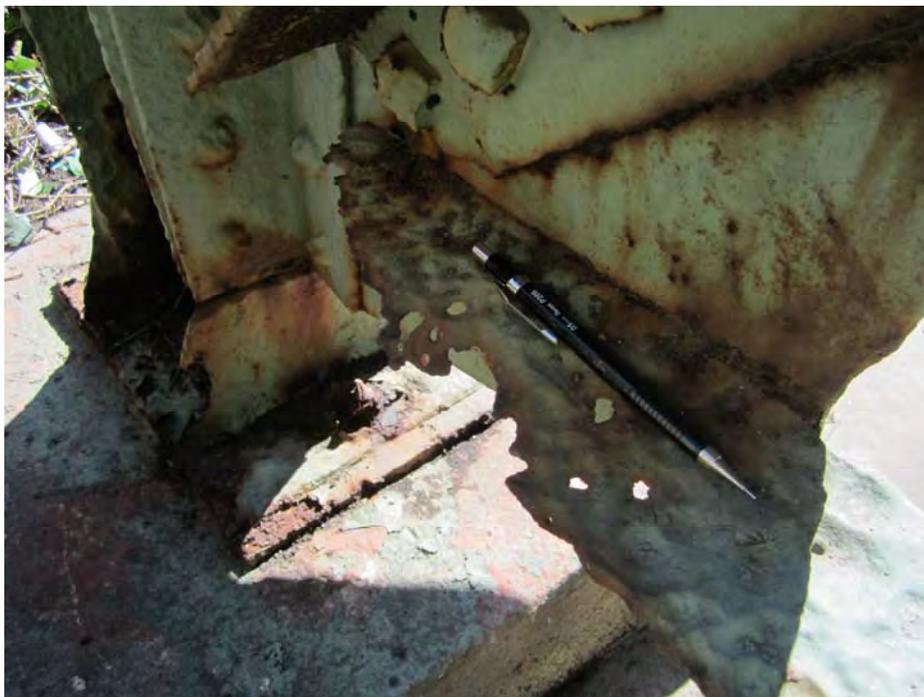
Photo # 14 - Substantial deterioration of horizontal bracing element, column connecting plates and anchors on the north column of Bent 1.

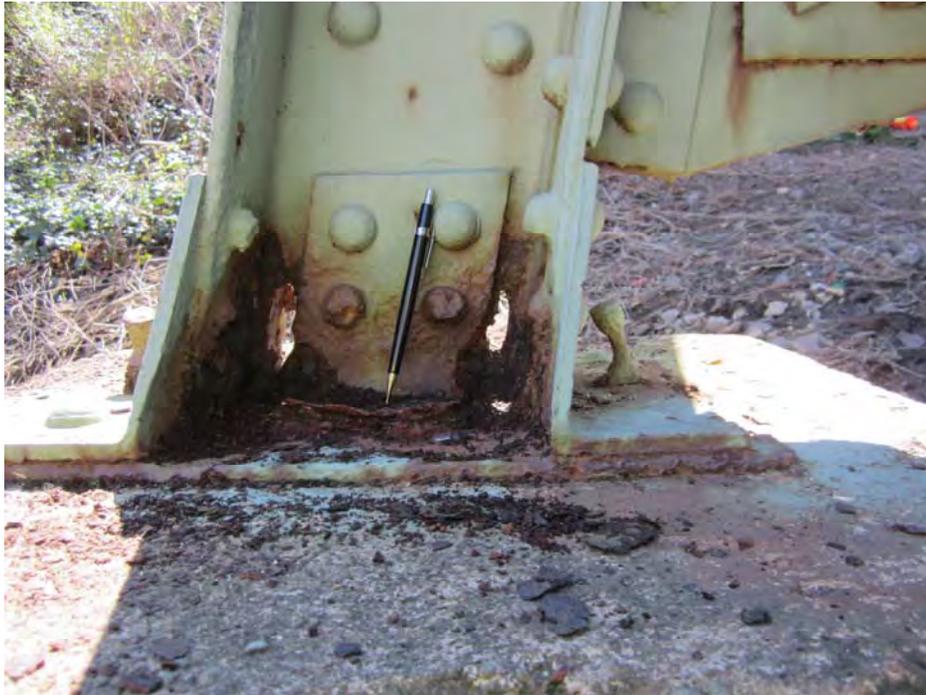
"Imminent" failure: The bottom six inches of the north column on Bent 3 exhibits several perforations in the column web and up to 100% section loss to portions of the web and flanges. Consequently, the bottom of the column web and portions of the existing flanges appear to have lost all load carrying capacity due to advanced deterioration. [See photos #15 & #16](#). Note that each angle is connected to the column flanges with four rivets. The bottom two rivets in each connection appear to have lost all load carrying capacity. A failure in the column base could cause surrounding elements to become overstressed or unstable, potentially leading to a partial or total collapse of the structure.

Photo # 15 – Column web and flanges areas of up to 100% section loss and substantial deterioration of connection to support components at the north column of Bent 3. The web and portions of the existing flanges appear to have lost all load carrying capacity.

Because the "imminent" failure of a column base could cause a catastrophic failure of the entire structure, we recommend that the structure be immediately closed to all traffic, both vehicular and pedestrian, until repairs are completed. Once repairs have been completed a new load rating analysis should be performed to determine the appropriate posting limit for the structure.

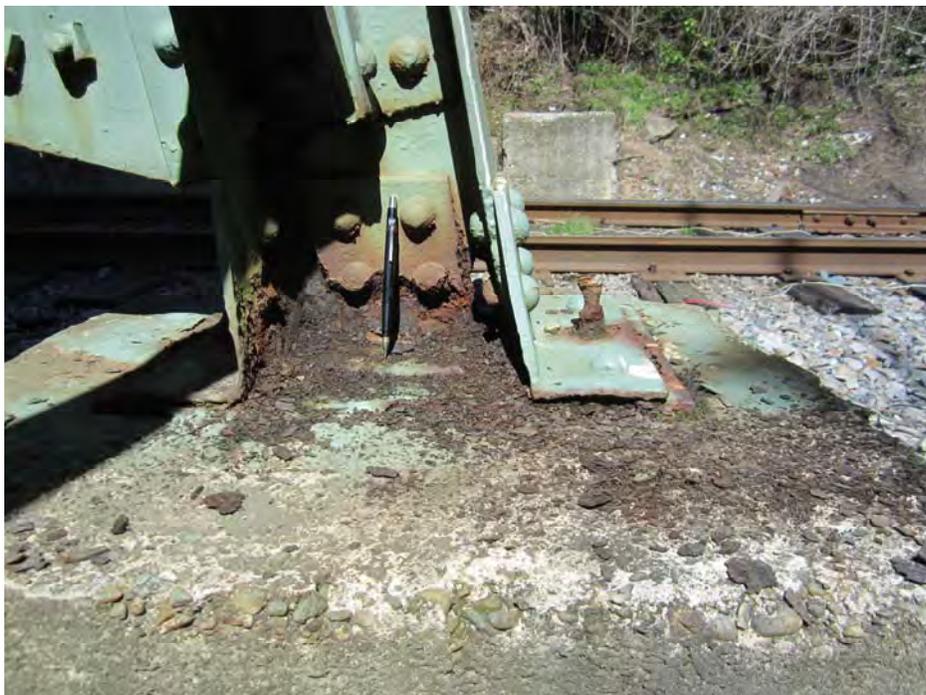
Also, in the same location it is evident the lack of positive anchor of the column support because the anchors and nuts are severely corroded.

Photo # 16 - This is the back view of the element in the photo above. Note the disintegration of the lower leg of the connecting angle, and the precarious conditions of the remaining part of both anchor bolts where the two nuts are practically missing leaving this column support with no positive anchor.

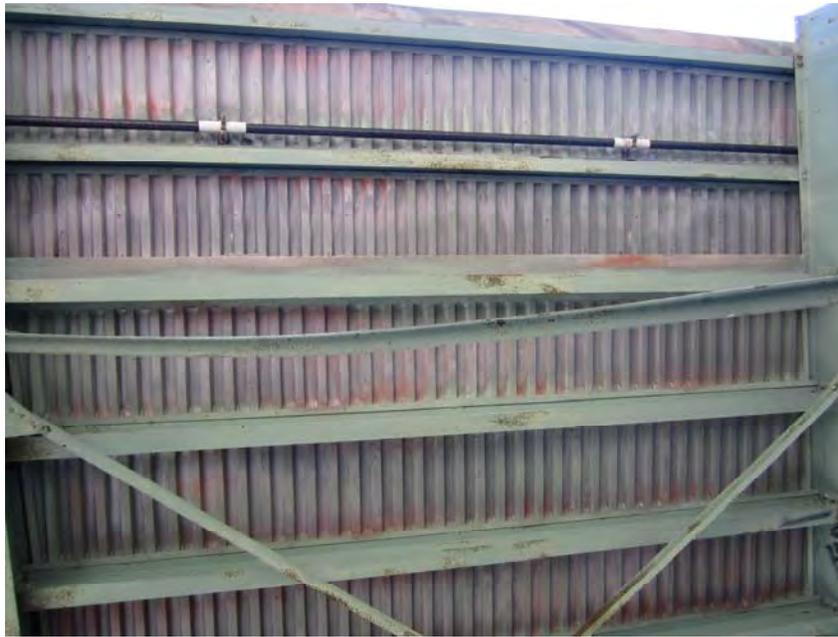
Photo # 17 - Buckling of diagonals for the lateral bracing between the south columns of Bents 3 and 4.

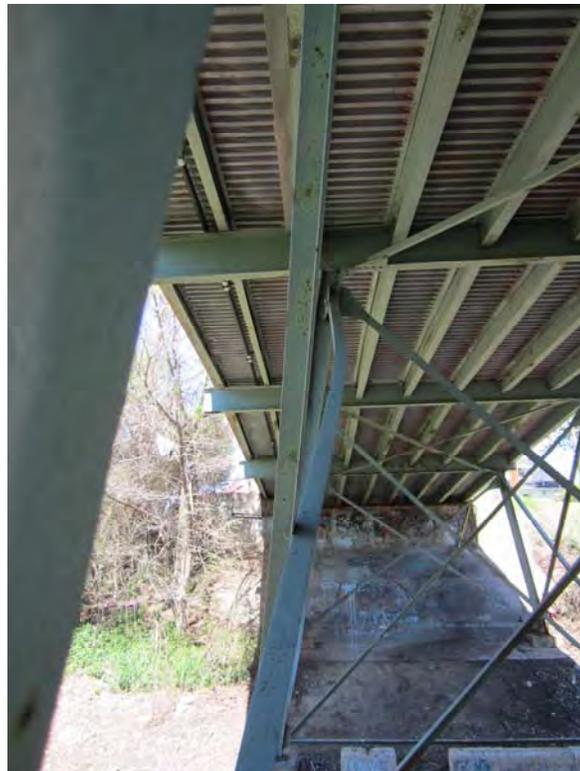
Photo # 18 - Buckling of the two diagonals for the lateral bracing between the south columns of Bents 3 and 4.

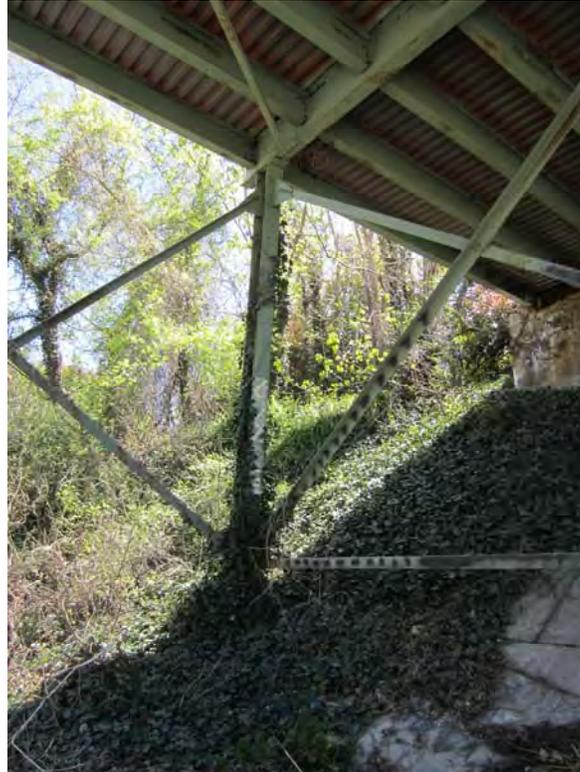
Heavy vegetation in Bent 4. [See photos #19 & #20](#).

Photo # 19 - Vegetation is growing around north column of Bent 4.

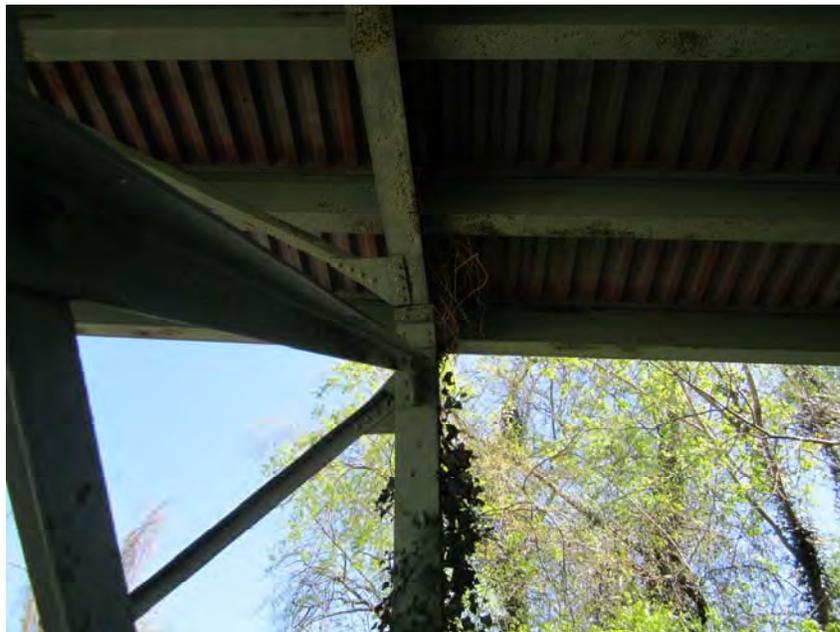
Photo # 20 - Vegetation growing around column bent cap at the north end of Bent 4.

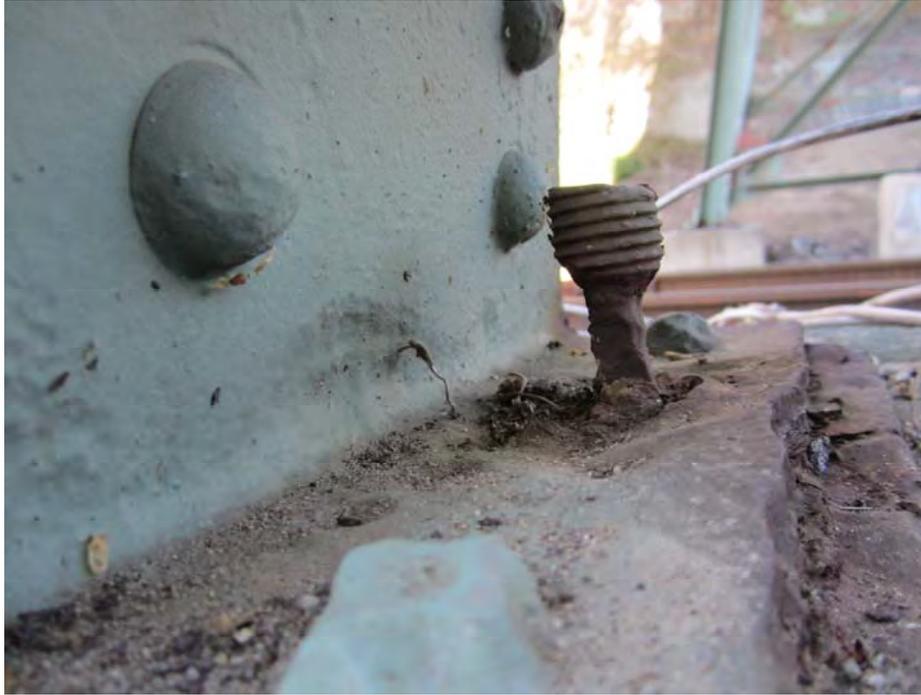
Photo # 21 – Typical condition of interior anchor bolts at the north columns of Bents 1 to 4.

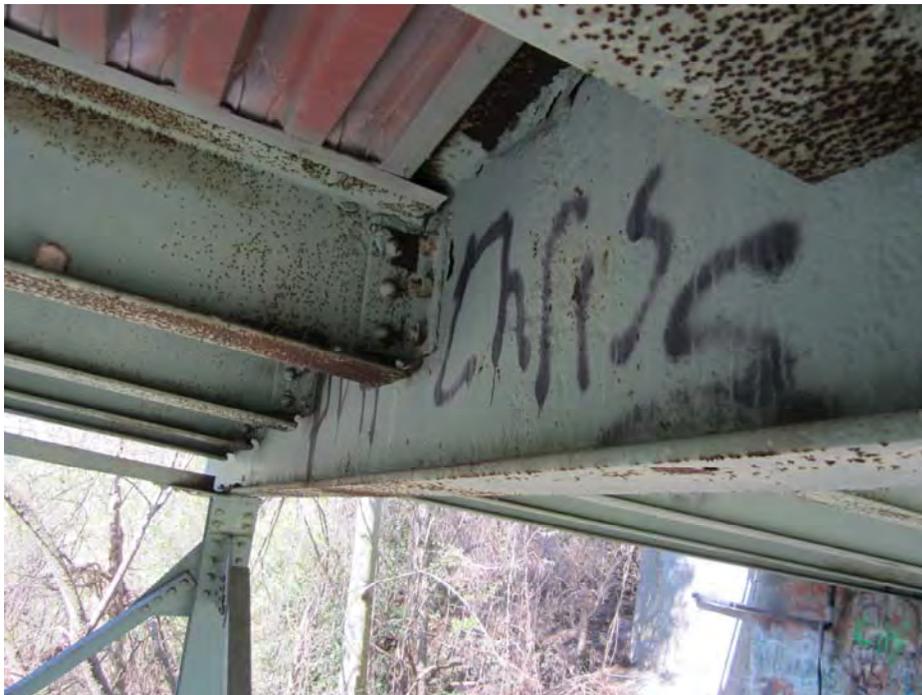
Bent cap of Bent 4 has minor exfoliation between Beams 2 and 3 along the underside of the top flange and top one inch of the web. [See photo #22](#). There is also pack rust between the cap and the north column, which has warped the bottom flange of the cap and the bearing plate at the top of the column.

Photo # 22 – Typical painted over exfoliations indicating insufficient cleaning before painting.

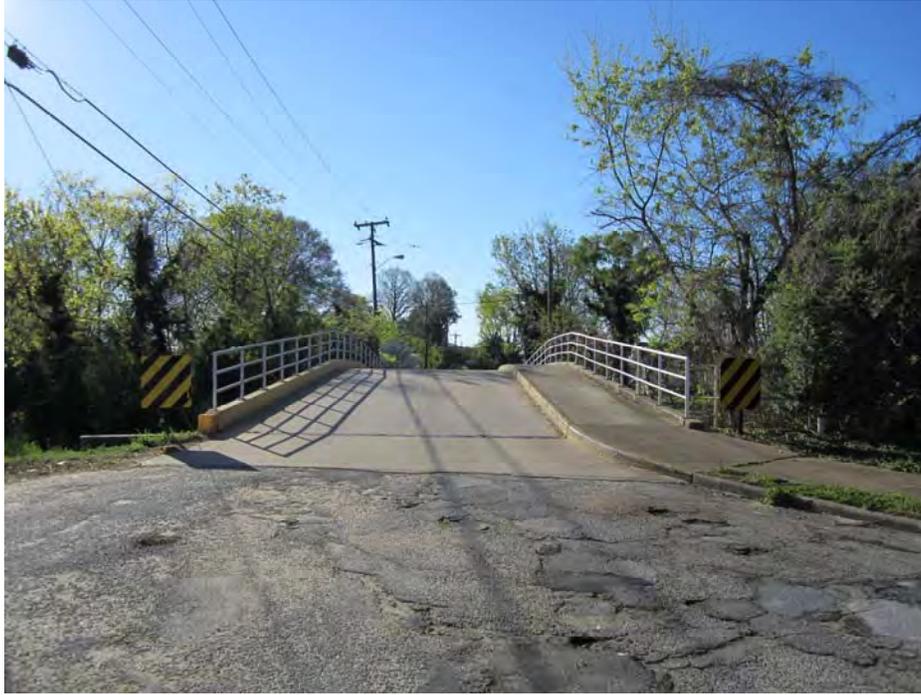
Photo # 23 - View of spalls in Abutment A asphalt approach.

1. Install approach guardrail, approach guardrail terminals, and transitions between approach guardrail and bridge railing at all four corners of bridge.
2. Pave approach roadway to correct settlement of approach at Abutment B.
3. Correct cracked and spalled asphalt pavement of approach at Abutment A.
4. Remove and re-erect No Parking sign on a new post 40 feet further west of the bridge posting sign in order to improve visibility to eastbound vehicles.
5. Raise both posting signs to standard signing heights.
6. Restore railing on top of right wingwall at Abutment A.
7. Replace the left object marker on both approaches since they slope in the wrong direction.

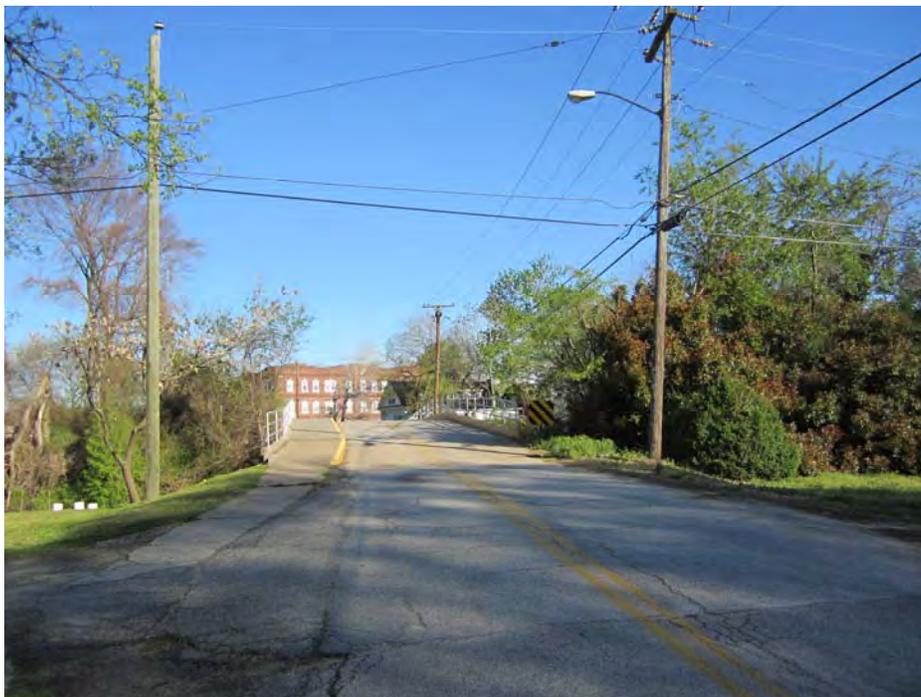
Photo # 24 - View of cracks in Abutment B asphalt approach.

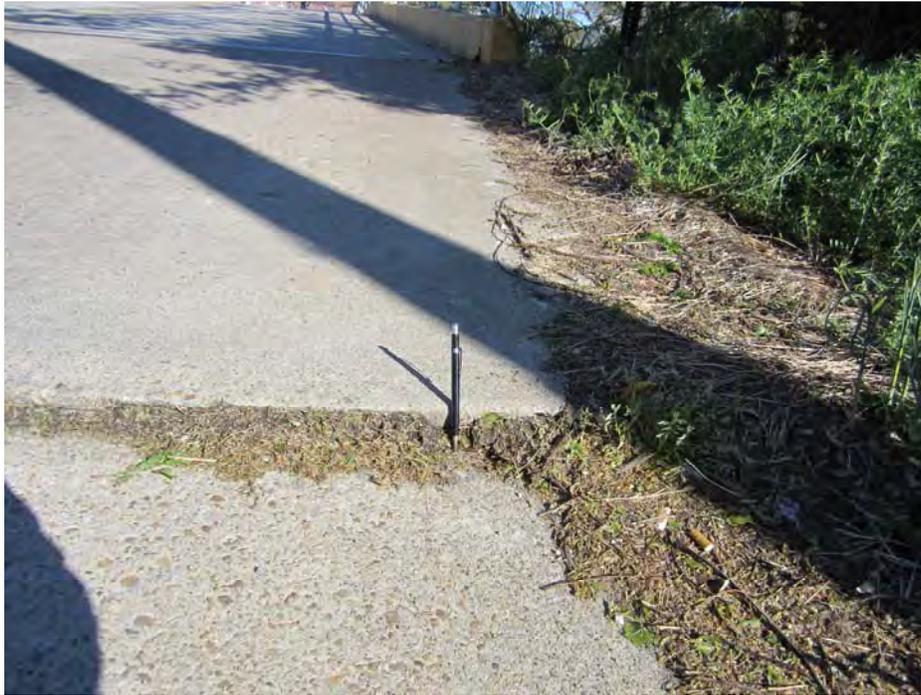
Photo # 25 - Right side of Abutment B approach slab has settled 2 1/4" ±.

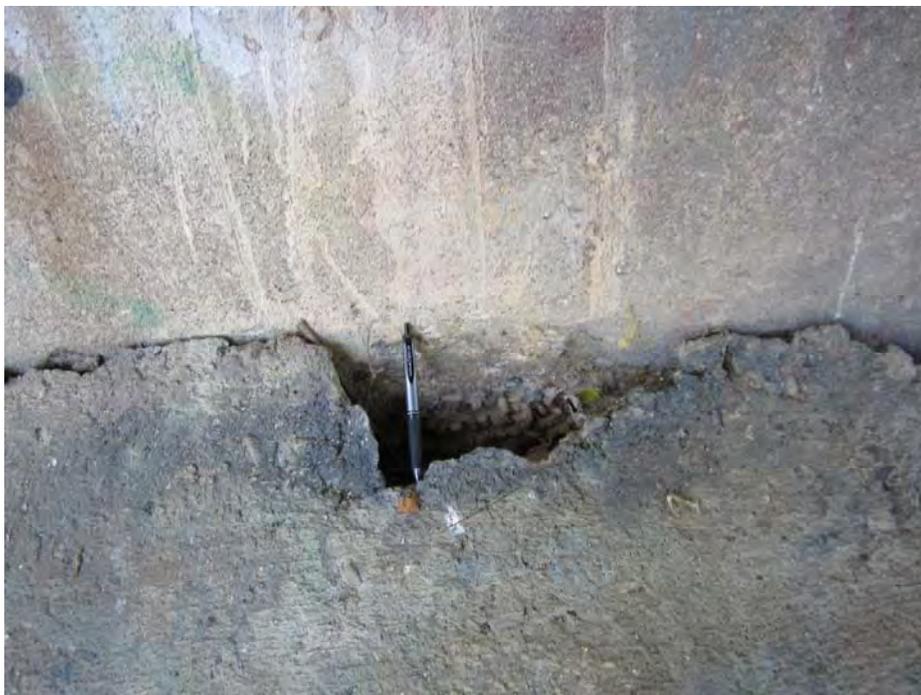
Photo # 26 – Void at the top of slope protection Abutment A.
